# REDDICK MANSION HISTORIC STRUCTURE REPORT

Completed for:  
The Reddick Mansion Association

The Reddick Mansion Historic Structure Report provides:

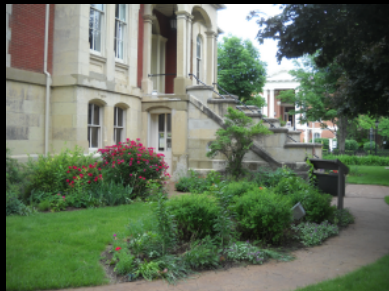
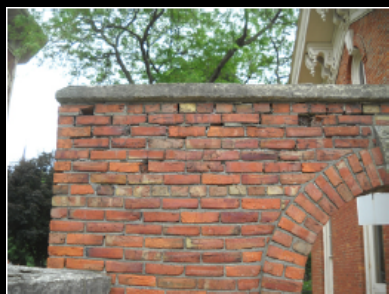
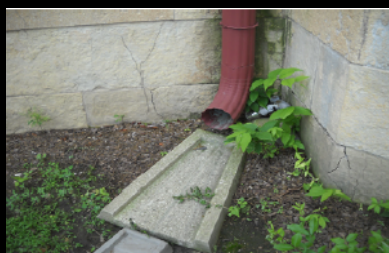
## Site

- The site on which the Mansion sits has a lovely park setting and is well maintained by volunteers.
- The pavement is in fair condition and is spalling in some locations. Stain and seal the sidewalk; site lighting and signage
- The site as it is, does not reflect the Reddick Family Period, when it was quite austere, based on historic photographs.
- The green space around the Reddick Mansion remain landscaped and vibrant in order to attract visitors.
- Parking lot: asphalt, striping, signage and concrete pad
- Iron fence and retaining wall:
  - Reset stone retaining wall as required; clean/paint fence
- Brick wall, west side of site
  - Reset stone cap, repoint/replace bricks as required
- Regrade soil around the Mansion perimeter to prevent water from entering foundation. Retain landscaping

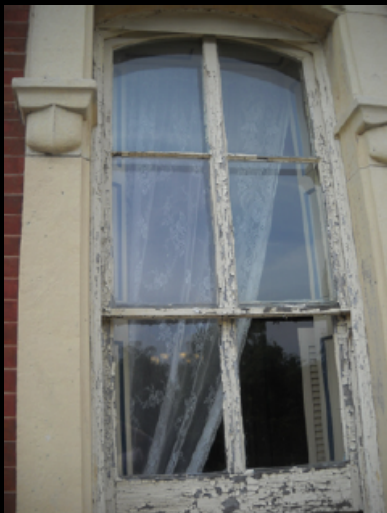
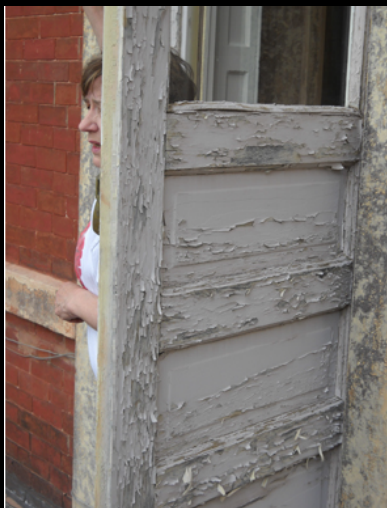
## Windows and Doors

- The south-facing Bedroom Level windows are in extremely poor condition and require immediate action. They are easily accessible from the porch roofs.
  - These windows must be stabilized immediately, and considered a first priority for restoration.
    - These six windows could be used as a pilot restoration program to gauge how long / how much a larger program would be.
- A large scale Window and Exterior Door/ Trim Restoration project should be undertaken as a first priority.
  - First priority: Bedroom Level windows
  - Second priority: Main Level.
  - Third priority: Lower Level and Servants' Level lunette windows
- A full "Window and Exterior Trim Restoration" documents were prepared by Basalay, Cary & Alstadt Architects, Lt. of Ottawa, IL in May 2011.
  - These documents can/should be used toward a full or phased restoration!

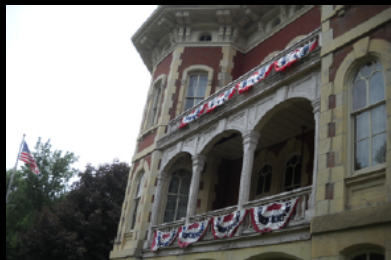
## East Porch

- Short term: scrape and paint in order to protect the wood from further damage owing to UV exposure.
  - Small openings in the porch structure should be closed so birds and animals will not nest within.
- Mid-term: The entire east porch should be stripped, sanded, primed and painted with two coats of high-quality exterior paint.
- Former openings on the floors need to be properly enclosed.
- The porch railings should be repaired and rotted elements replaced

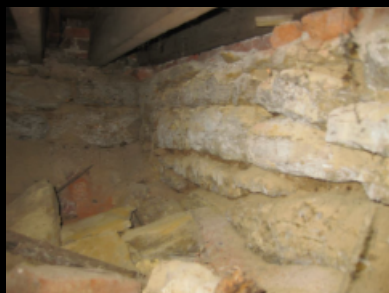
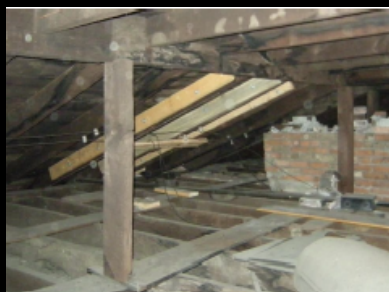
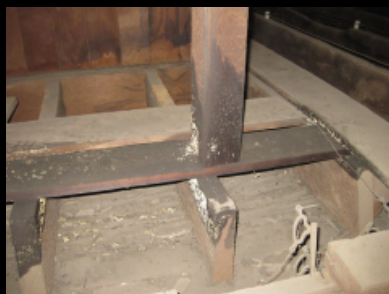
## Structural

- The existing structural system is sound
- If/when mechanical equipment is installed in the Attic, the Attic floor joists may have to be reinforced
- The roof rafters may need reinforcement to ensure they can support the snow load once the attic fully insulated

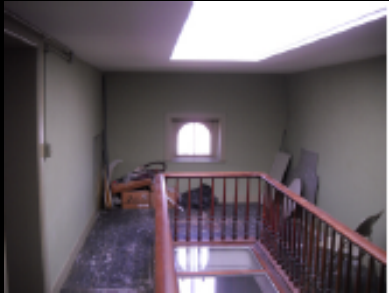
## Servant's Level / Fourth Floor

- The rooms on the Servant's Level should be refurbished and used for museum offices or office rental
  - Plaster must be repaired or replaced and painted
  - Without a second means of access, (and due to the steep existing stairs) it would not be possible to have public visitation on this level.
  - Once the elevator is installed, these spaces may become available for museum use or office rental.

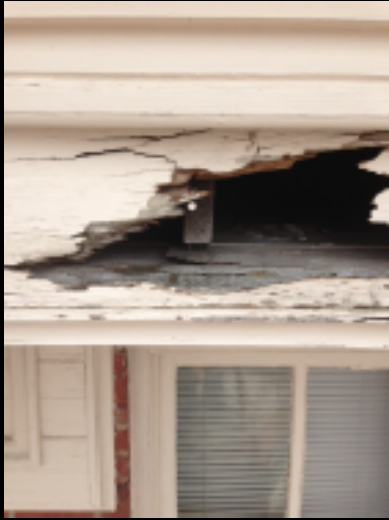
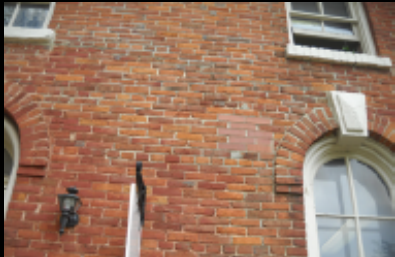
## Caretaker's House Exterior

- Brick masonry is in fair to poor condition, and in general need of re-pointing.
  - There are some seriously deteriorated areas in need of patching or possible replacement.
- The wood cornice is suffering from spot deterioration.
  - Repairs should be made to the cornice as soon as possible to prevent bird and animal infestation.
- The windows and doors are in overall fair condition
