# REDDICK MANSION HISTORIC STRUCTURE REPORT

Completed for:  
The Reddick Mansion Association

The Reddick Mansion Historic Structure Report provides:

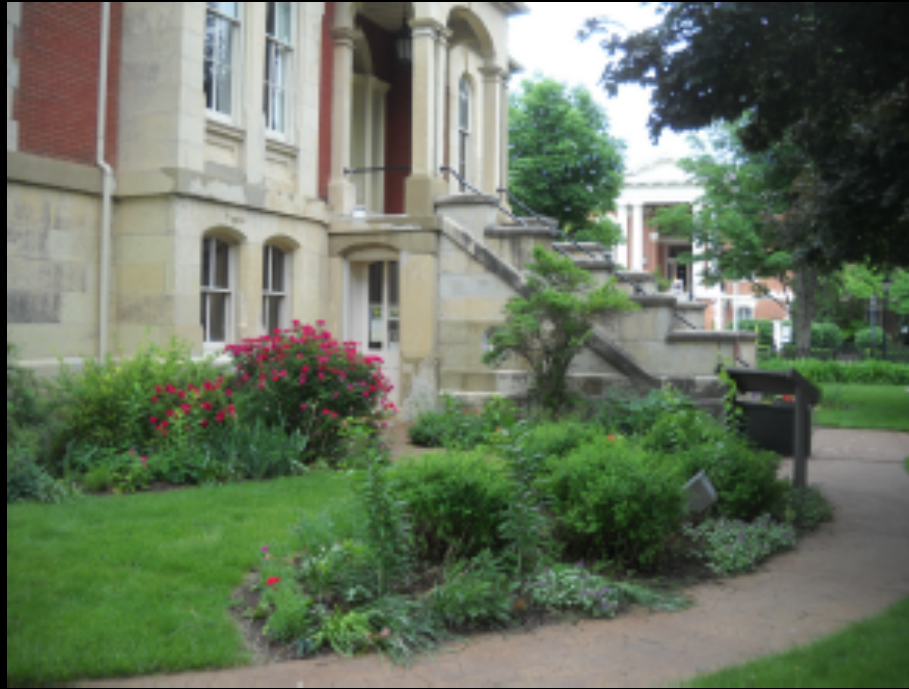
SITE

- The site on which the Mansion sits has a lovely park setting and is well maintained by volunteers.
- The pavement is in fair condition and is spalling in some locations. Stain and seal the sidewalk; site lighting and signage
- The site as it is, does not reflect the Reddick Family Period, when it was quite austere, based on historic photographs.
- The green space around the Reddick Mansion remain landscaped and vibrant in order to attract visitors.
- Parking lot: asphalt, striping, signage and concrete pad
- Iron fence and retaining wall:
  - Reset stone retaining wall as required; clean/paint fence
- Brick wall, west side of site
  - Reset stone cap, repoint/replace bricks as required
- Regrade soil around the Mansion perimeter to prevent water from entering foundation. Retain landscaping

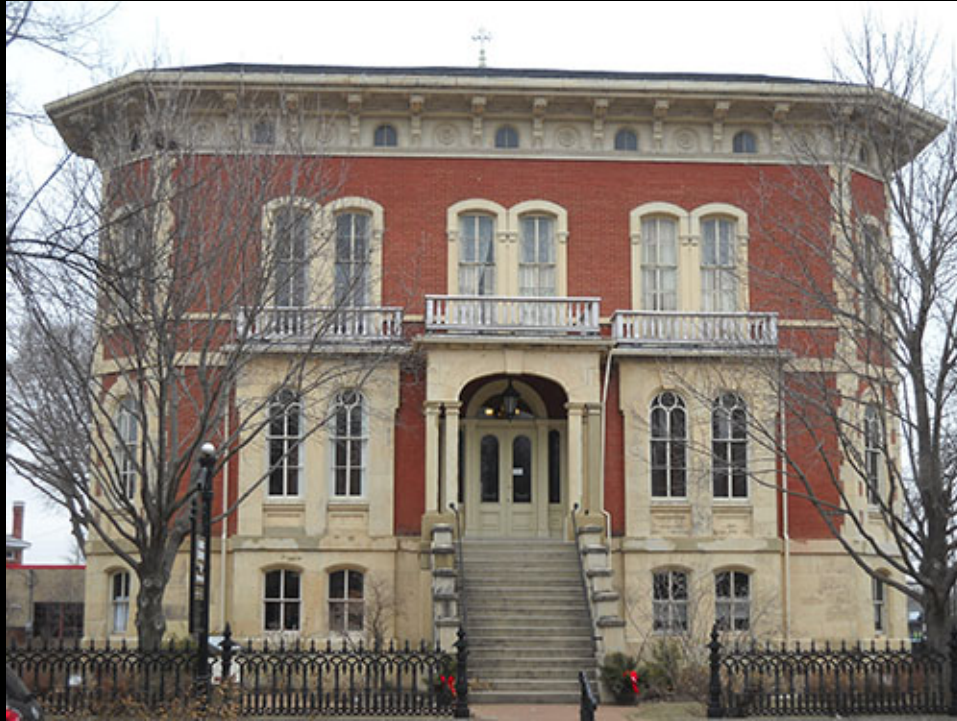
EXTERIOR

- Short Term:
  - Spot repoint 10% of limestone string courses
  - Undertake mortar analysis to identify original mortar mixture
- Mid Term:
  - Repoint and repair masonry on interior of Boiler Room
  - Repair cracked and broken stone at base of Exterior
  - Disassemble front entry steps; replace steps; reassemble walls and flash appropriately
- Long-Term:
  - Repoint entire building
  - Repair all limestone (remove and replace patches)
  - Install new stone or stone veneer at base
  - Dig ditch around perimeter of building; repoint and damp-proof foundation; install perimeter drain system

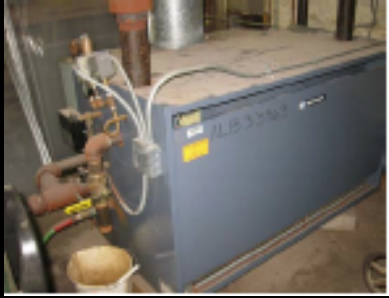
- A ground-source heat pump (GSHP) system is recommended for ducted air conditioning with supplemental heat/dehumidification.
  - The radiators would be retained and re-used
  - The GSHP system will operate for about the same cost as the current system (\$9,000/year)
    - But will provide cooling and control for humidity.
  - As compared to a standard air conditioning system with reheat:
    - We estimate an annual savings using the GSHP system of about \$2,500.00, but will have a roughly 10-year payback.
  - The new ducted-system can be effectively integrated within the historic structure without disturbing too much historic fabric.

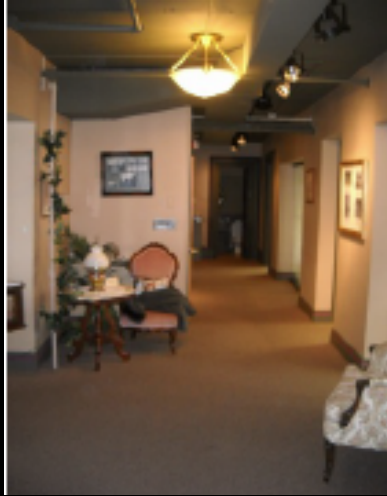
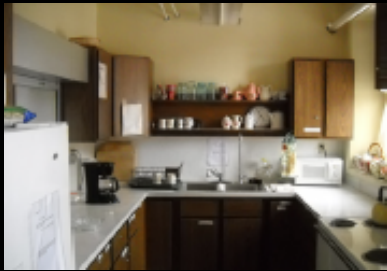
- The rooms at the Lower Level have lost most of their historic integrity due to modernizations.
- However, the Southeast Room might be modified to interpret it as a Servants' Dining or Sitting Room.
- The original Kitchen was probably located in the Northeast Room.
  - This space may be renovated with a new kitchen that is more serviceable
  - It can be designed to be “in keeping” with a historic home of this period
  - A modern kitchen will serve “double-duty” as a catering kitchen for the Main Level event space.

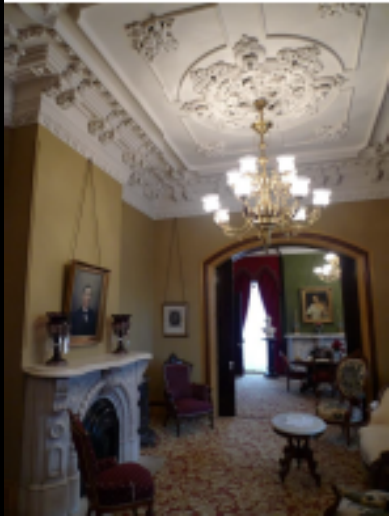
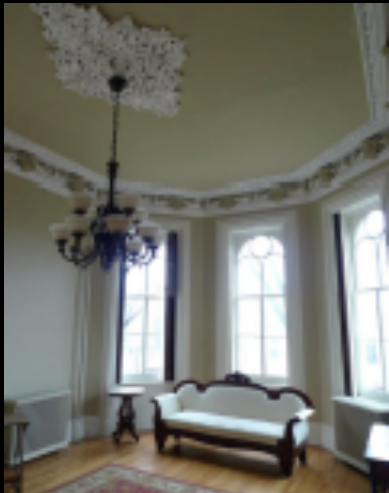
- The Central Hall, the Southeast and Center East Parlors, and the Dining Room remain interpreted historic spaces.
  - Walls and ceilings should be painted in the original paint colors based on our analysis.

- Because the original wood grained trim was stripped, it may remain a complimentary solid color.
  - The original floors are covered with a new hardwood floor. It should be stained darker to be more in keeping with the original wood in the house.

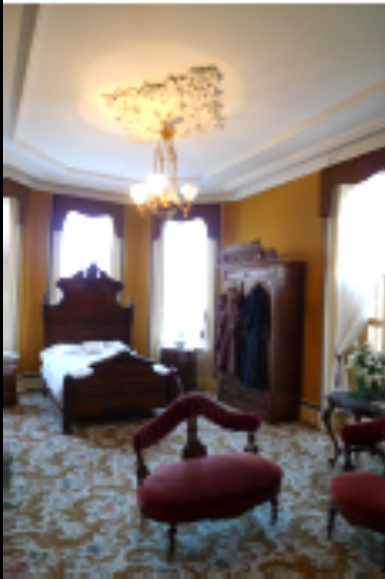
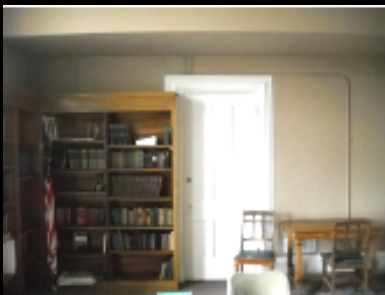
- The Central Hall and Southeast Bedroom are interpreted museum spaces and should remain as such.
  - Walls and ceilings in all rooms on this level should be painted in the original paint colors identified in our analysis.

- The Central Hall's partitions should be removed, as they confuse the interpretation of the space. RMA will have to negotiate with local fire dept. and code officials

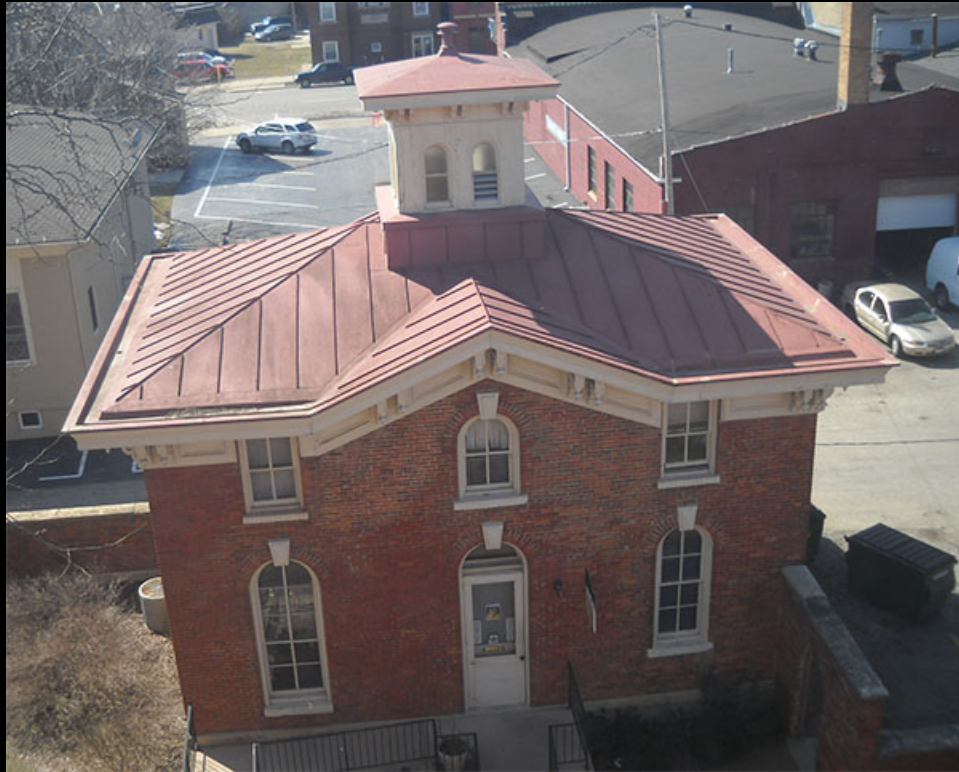
CARETAKER'S HOUSE EXTERIOR

- Brick masonry is in fair to poor condition, and in general need of re-pointing.
  - There are some seriously deteriorated areas in need of patching or possible replacement.
- The wood cornice is suffering from spot deterioration.
  - Repairs should be made to the cornice as soon as possible to prevent bird and animal infestation.
- The windows and doors are in overall fair condition
